# Manhole Inspection Summary

Manhole # S35U\_\_042MH

Insp Date: **3/20/08 10:36 AM**

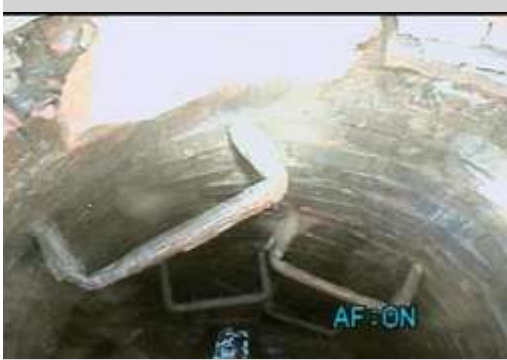
Defect 2

Condition: ☐ Sound ☐ Cracked ☐ Root Intrusion ☒ **Loose Brick** ☒ **Deteriorated**

deteriorated chimney, loose bricks, offset

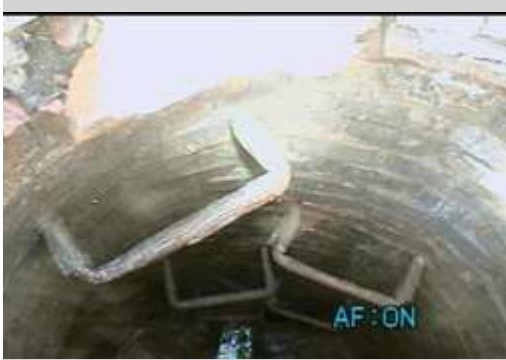
Defect 1

**Steps** Count: **4** Missing: **0** ☒ **Corroded**

steps

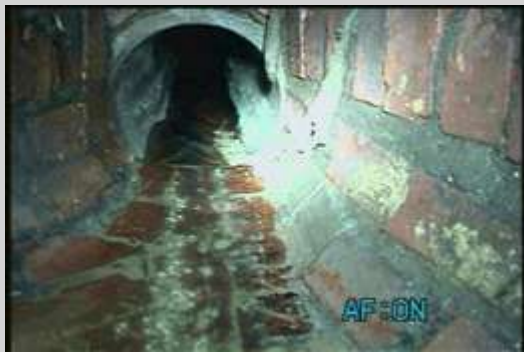
12 O'Clock Outflow

8 in. Circular Gravity Sewer  
Pipe Out @ 12 O'Clock

Pipe Material: **Clay** ☐ Pipe Lined

Invert Depth: **10.30** (ft.) Flow Characteristics: **Fast**

Infiltration: **None** Pipe Seal Cond: **Unknown**

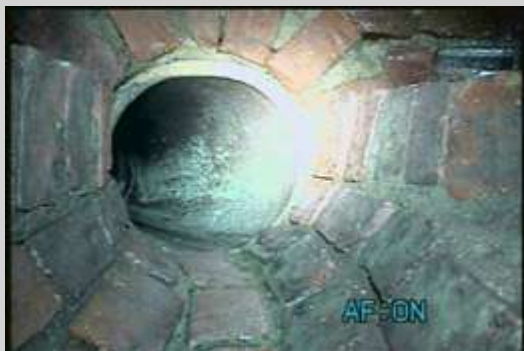
3 O'Clock Inflow

8 in. Circular Gravity Sewer  
Pipe In @ 3 O'Clock

Pipe Material: **Clay** ☐ Pipe Lined

Invert Depth: **10.20** (ft.) Flow Characteristics: **Fast**

Infiltration: **None** Pipe Seal Cond: **Unknown**

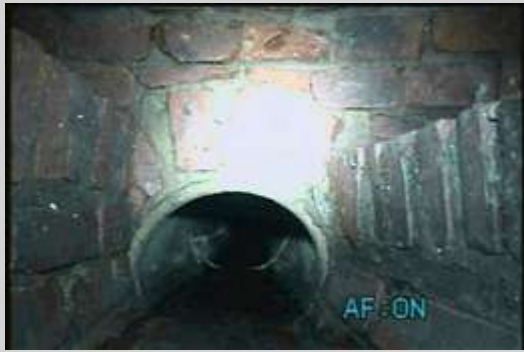
6 O'Clock Inflow

Pipe In @ 6 O'Clock

Pipe Material: **Clay** ☐ Pipe Lined

Invert Depth: **10.10** (ft.) Flow Characteristics: **Slow**

Infiltration: **None** Pipe Seal Cond: **Unknown**

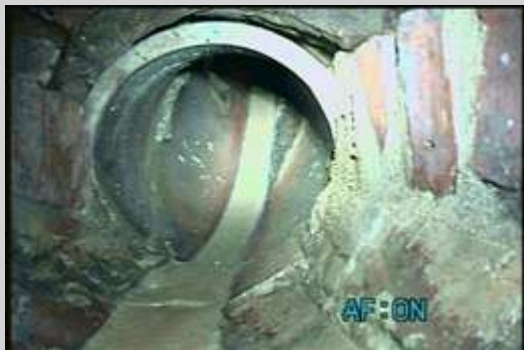
9 O'Clock Inflow

Pipe In @ 9 O'Clock

Pipe Material: **Clay** ☐ Pipe Lined

Invert Depth: **10.00** (ft.) Flow Characteristics: **Slow**

Infiltration: **None** Pipe Seal Cond: **Unknown**
